MED GRILL  
4512 WEST SAANICH ROAD, SAANICH, BC V8Z 3G4  
BUILDING ASSESSMENT  
**STRUCTURAL ENGINEERING SERVICES**

Project: 12585.01  
June 25, 2025

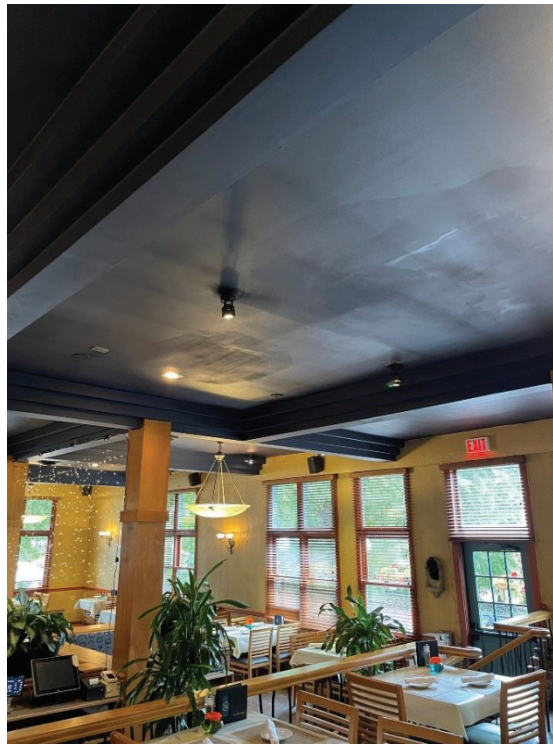
Numerous ceiling patches were observed on the main level which appeared to be a result of roof leakage. This is an indication that the roof system is beginning to fail and / or has reached the end of its useful life. Access to the roof cavity was not provided, but there is a possibility the roof joists and beams could be exposed to excessive moisture and could begin to rot.

*Figure 2: Ceiling Patch*

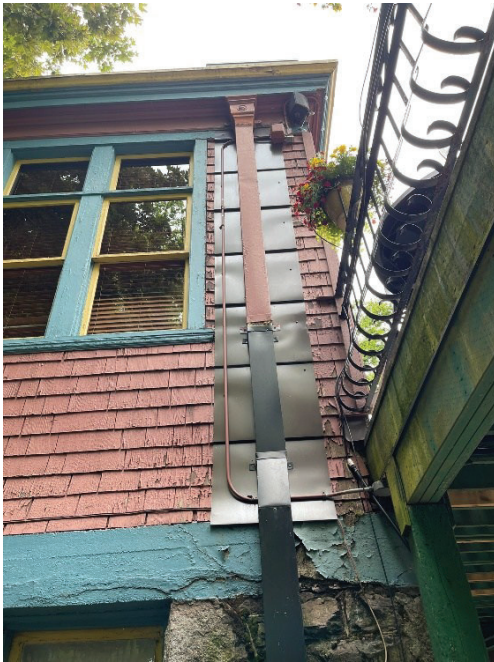
The roof drainage does not appear to be working properly at the gutter and down spout locations, resulting in water compromising the exterior building finishes, as shown in Figure 3. Additionally, it appears that water has compromised the building envelope and entered the wood stud wall cavity on the main level, as shown by the wall patching in Figure 4 below. Although not observed while on site, the lower-level tenant also noted multiple issues with water ingress into the stud wall cavity which required extensive repairs.

*Figure 3: Gutter and Down Spout*

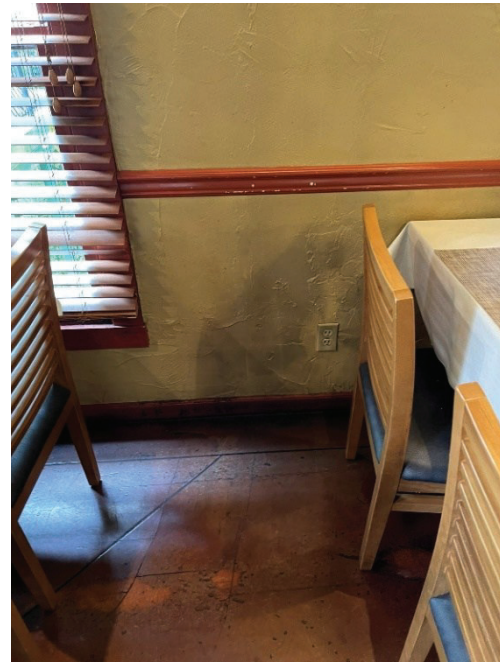
*Figure 4: Main Level Interior Wall Patch*

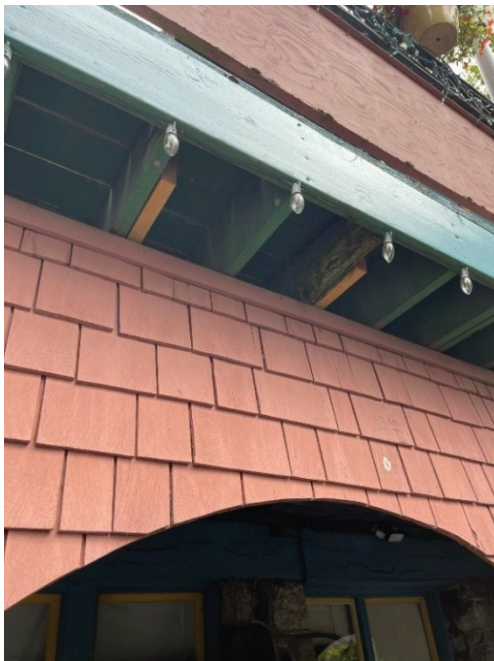
Deterioration and rot of the walkway joists and post base connection were observed in many locations. Refer to Figure 5 and Figure 6 below.

*Figure 5: Deck Joist Rot*

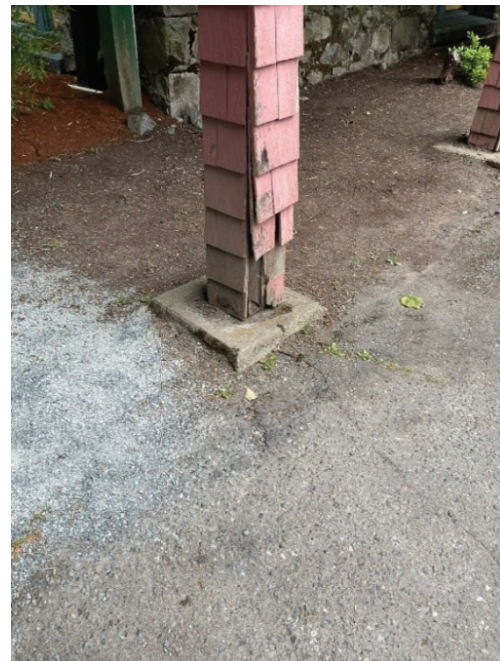
*Figure 6: Deck Post Base Connection*
